TECHNOLOGY AND ORGANIZATION OF CONSTRUCTION ТЕХНОЛОГИЯ И ОРГАНИЗАЦИЯ СТРОИТЕЛЬСТВА

Resource-Saving Technology for Dismantling the Supporting Decking of Reinforced Concrete Ribbed Slabs during Reconstruction and Demolition of Buildings

Keywords: reconstruction and demolition of buildings, dismantling of coatings, load-bearing reinforced concrete decking, ribbed slabs, monolithic seams and joints, sling loops

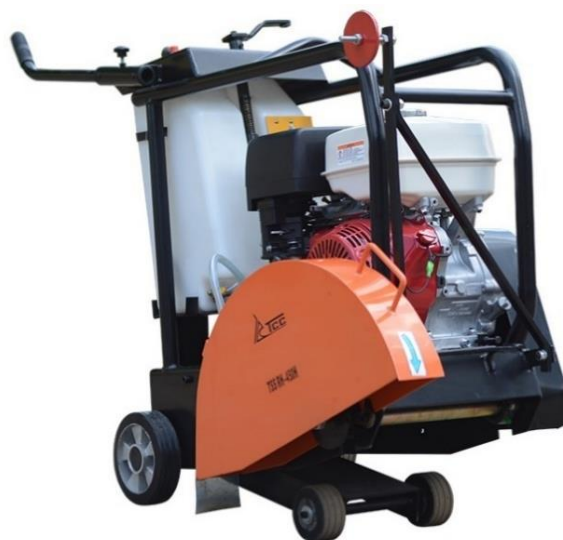
Being aware of these features enabled us to identify the required cutting depth of the seam, which should correspond to the height of the upper (expanded) part of the longitudinal seam and be equal to 200 mm. This should prevent accidental damage to the ledges in the longitudinal ribs of the slabs by the rotating diamond cutter disc. In order to perform this technological operation, a seam cutter with a maximum cutting depth of 200 mm can be recommended, e.g., the TSS RH-500G brand, its general view is shown in Fig. 4.

Fig. 4. General view of the TSS RH-500G seam cutter with the diamond disc removed

- the existing sling loops are cut off;
- cuts are made with a depth of 200 mm along the longitudinal seams and transverse joints between the ribbed plates using a seam cutter, e.g., TSS RH-500G brand, with a diamond disc with a diameter of 500 mm;

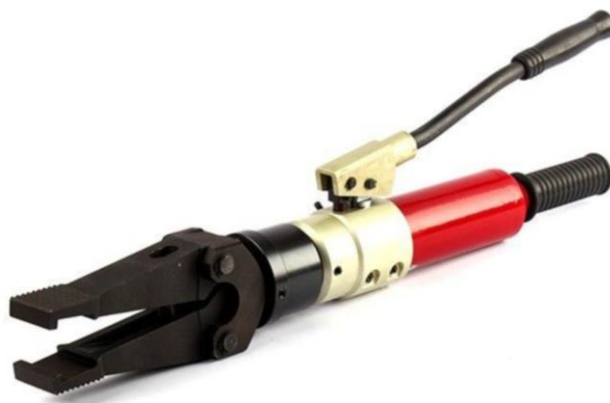
The resulting data enables us to conclude that after the slab has been freed from the welded joints with the rafter structures and at least the joints and seams between the slabs from mortar and concrete have been partially freed, the outermost slab in the row before lifting can be easily moved away from the adjacent slab using a self-contained wedge of the KRA1150 brand with a force of up to 10 kN, its general view is shown in Fig. 5, or two mounting crowbars.

Fig. 5. General view of the self-contained release wedge of the KRA1150 brand

- plates with visible defects are identified that are unacceptable in compliance with GOST 9491-60 with the appropriate marking made;
- before a slab is lifted, it is made sure that it is completely released from attachment to the truss or beam of the coating by shifting from the adjacent slab along the supporting rafter structures by means of a sliding self-contained wedge KR2,5120 or two 20-30 mm mounting crowbars.;
